## Re-Use Guidelines

### Hangar 2 (Building No. 46) NASA Ames Research Center Moffett Field, California

August 30, 2006

Prepared by  
**PAGE & TURNBULL, INC.**  
San Francisco, California

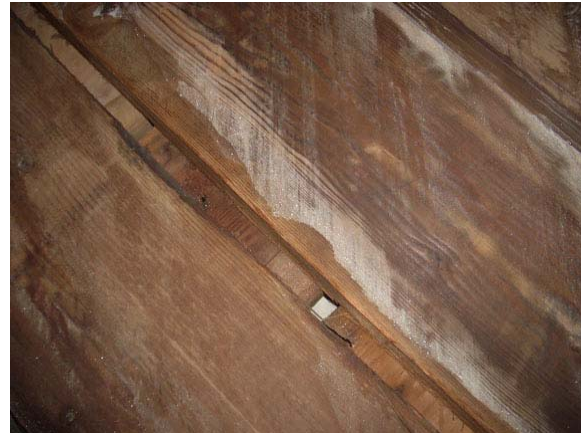
**Figure 38.** FRT salt deposits on diagonal sheathing of interior of door lintel box girder, north girder, Hangar 2.

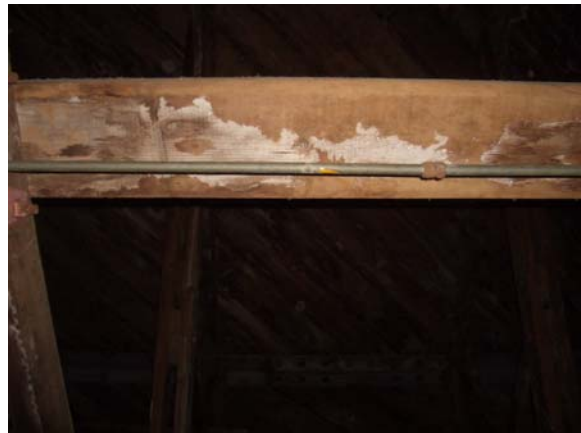
**Figure 39.** FRT salt deposits on a truss member supporting clamshell roof, north end Hangar 2.

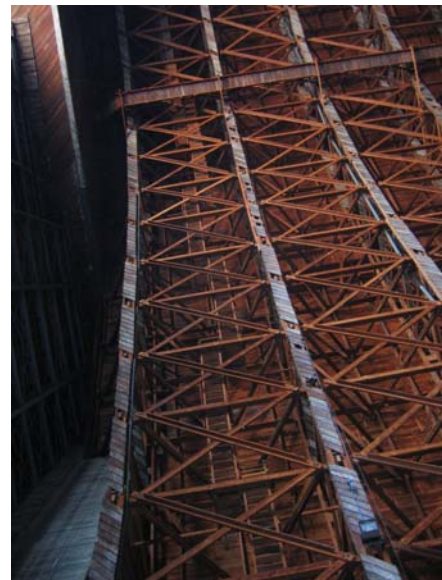
The underside of the catwalks exhibits white stains that appears consistent with the water staining and FRT leaching seen throughout the hangar. Because of safety concerns, the ladders and catwalks were not accessible. It can be argued that they are no longer capable of performing their intended

**Figure 43: Braces, ladder and catwalk assembly between Bents #1 & #2, Hangar 2.**

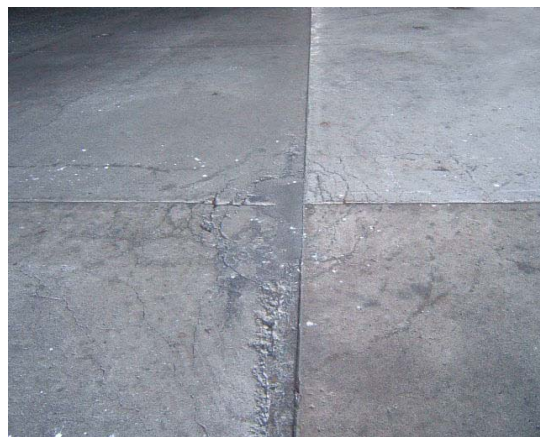
Minor cracking is evident throughout the slab, particularly at the corners of the floor panels where the slab is weakest (**Figure 44**). These cracks are typical for large concrete pours and do not appear to affect the structural performance of the foundation. The slab appears to be intact with no major swells or dips.

**Figure 44. Concrete floor slab (typical), Hangar 2 south entry.**

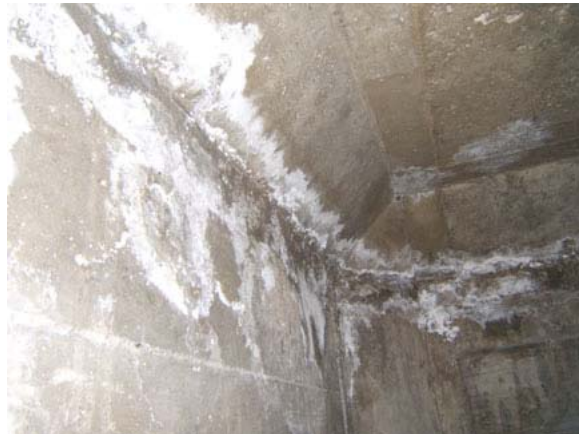
In addition to the organic growth and efflorescence, both of which are agents of deterioration, the intrusion of water caused chemical changes to the concrete. Water leaches salts and minerals from the concrete, lowering the pH of the naturally alkaline material. The alkaline environment of concrete suppresses oxidation reactions. As the concrete's alkalinity is reduced, the opportunity for oxidation increases. This contributes to the corrosion of the steel reinforcement bar embedded

**Figure 45: Efflorescence on the interior of the door tower, Hangar 2 southeast tower.**

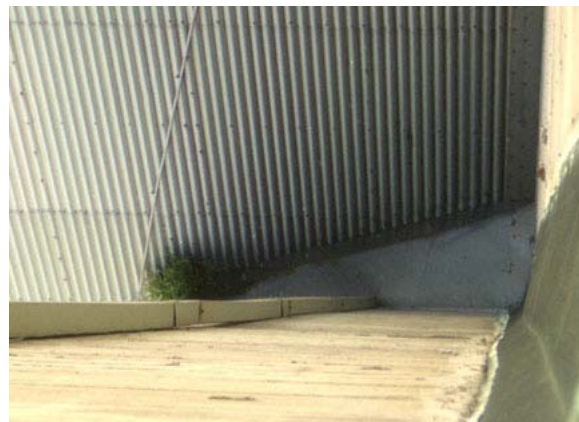
**Figure 46. Organic growth found at junction between roof slope and hangar door, Hangar 2 southwest tower junction.**

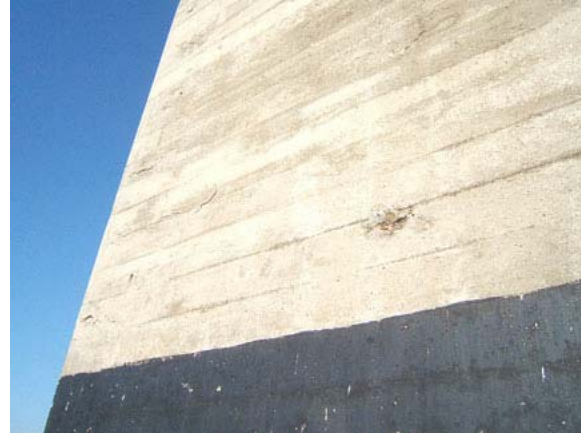
within the tower. The exterior of all towers show minor spalling, particularly at the corners. Shallow placement of reinforcement bars is the probable cause of this condition. The expansion of the corroding steel has caused cracking in the concrete, which has allowed more moisture to intrude into the system. Left unchecked, this cycle will cause the face of the concrete to spall (**Figures 47 & 48**).

**Figure 47. Concrete spall on northwest corner tower, Hangar 2.**

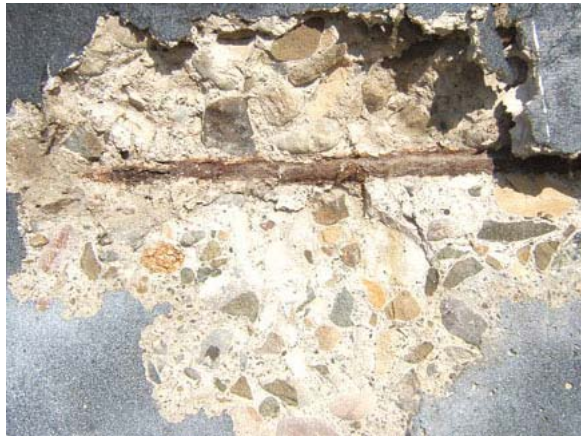
**Figure 48. Detail of concrete spall, northwest door tower, Hangar 2.**

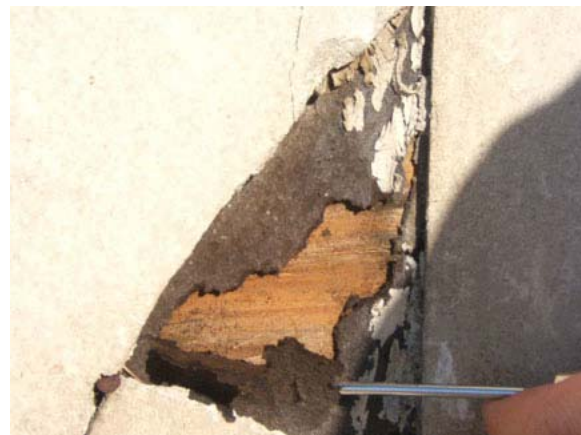
**Figure 50. Deteriorated cement asbestos panel showing underlayment of tarpaper and wood substrate, northern corner of the west façade, Hangar 2.**

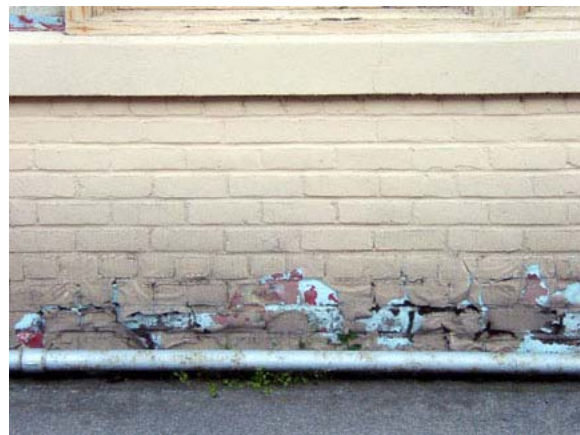
**Figure 51. Water table, line of rising damp evaporation causing paint to fail on west façade of Hangar 3,**
